EVALUATION OF HIGH PERFORMANCE CONCRETE OVERLAYS PLACED ON ROUTE 60 OVER LYNNHAVEN INLET IN VIRGINIA

MICHAEL M. SPRINKEL, P.E. Research Manager

CELIK OZYILDIRIM, Ph.D. Principal Research Scientist

FINAL REPORT

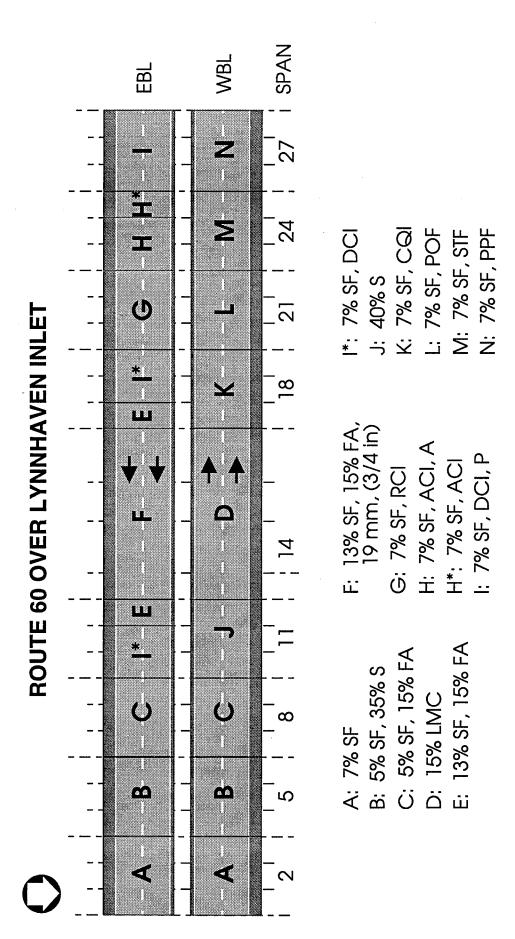
Figure 1. Plan View for Overlays on Two 28-Span Bridges on Rte. 60 Over Lynnhaven Inlet

A site location map for the two bridges is shown in Figure 1. Initially, the westbound bridge (WBL) was overlaid while traffic used the eastbound bridge (EBL). Then, traffic was detoured to the WBL while the EBL was overlayed.

The installation included 13 different concrete mixtures, an overlay with a thickness of only 0.75 in (19 mm), and spans with and without topical treatments of two corrosion inhibitors for a total of 16 different overlays. The overlay types are identified in Figure 1 as follows: 7% silica fume (SF); 5% SF and 35% slag (S); 5% SF and 15% class F fly ash (FA); 15% latex-modified concrete (LMC); 13% SF and 15% FA;, 13% SF and 15% FA placed 0.75 in (19 mm) thick; 7% SF and Rheocrete corrosion-inhibiting admixture (CIA) (RCI); 7% SF, Armatec CIA (ACI), and ACI topical treatment (A); 7% SF and ACI; 7% SF, Darex CIA (DCI), and Postrite (P) topical treatment; 7% SF and DCI; 40% S; 7% SF and shrinkage-reducing admixture (CQI); 7% SF and polyolefin fibers (POF); 7% SF and steel fibers (STF); and 7% SF and polypropylene fibers (PPF). With the exception of system F, overlays were required to have a minimum thickness of 1.25 in (32 mm). In addition, system E had a variable thickness that ranged from 1.25 to 0.75 in (32 to 19 mm) to provide good ride quality.
